PRINCESS 30DS

**SUBJECT
TO SURVEY**

Marine Projects' 30ft cruiser is a firm favourite with both offshore and inland boaters - and deservedly so. Tony Jones joins surveyor Frank Verrill for a close look at a 1985 model

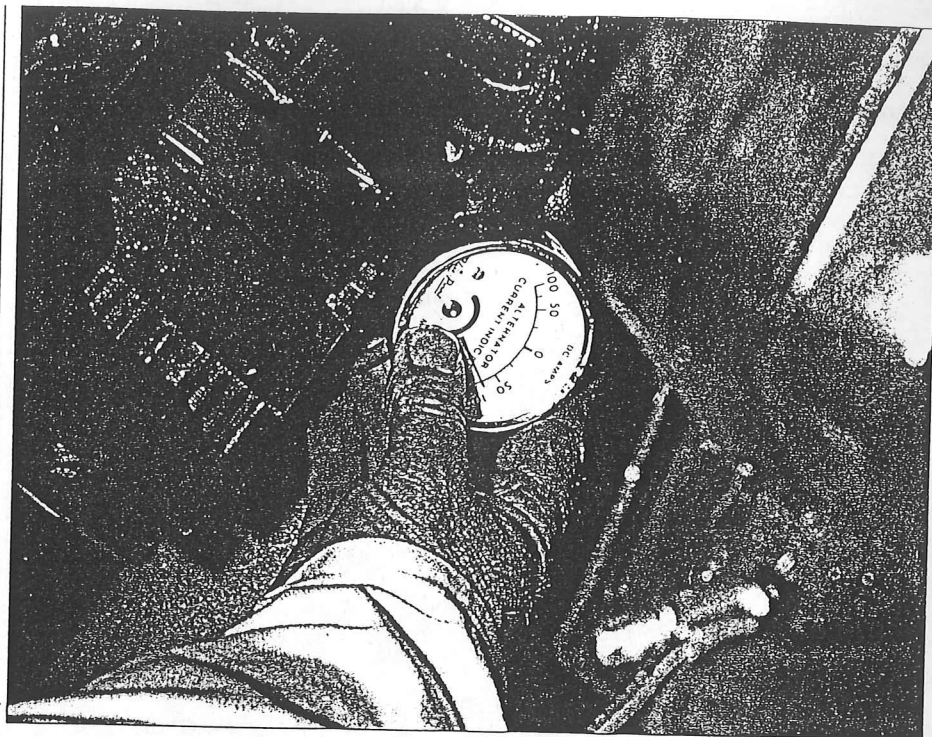
Checking the alternator output with an induction ammeter.

After fifteen minutes, the gauges showed that the engines were well up to normal temperature. But with both tachometers showing 1500rpm, Frank's mechanical rev counter indicated 1250rpm on the port engine and 1325rpm on the starboard. On checking the alternator outputs, Frank found that the starboard engine was pumping out 70A, and that voltage on the starboard battery was low - the battery would probably need replacing in the near future.

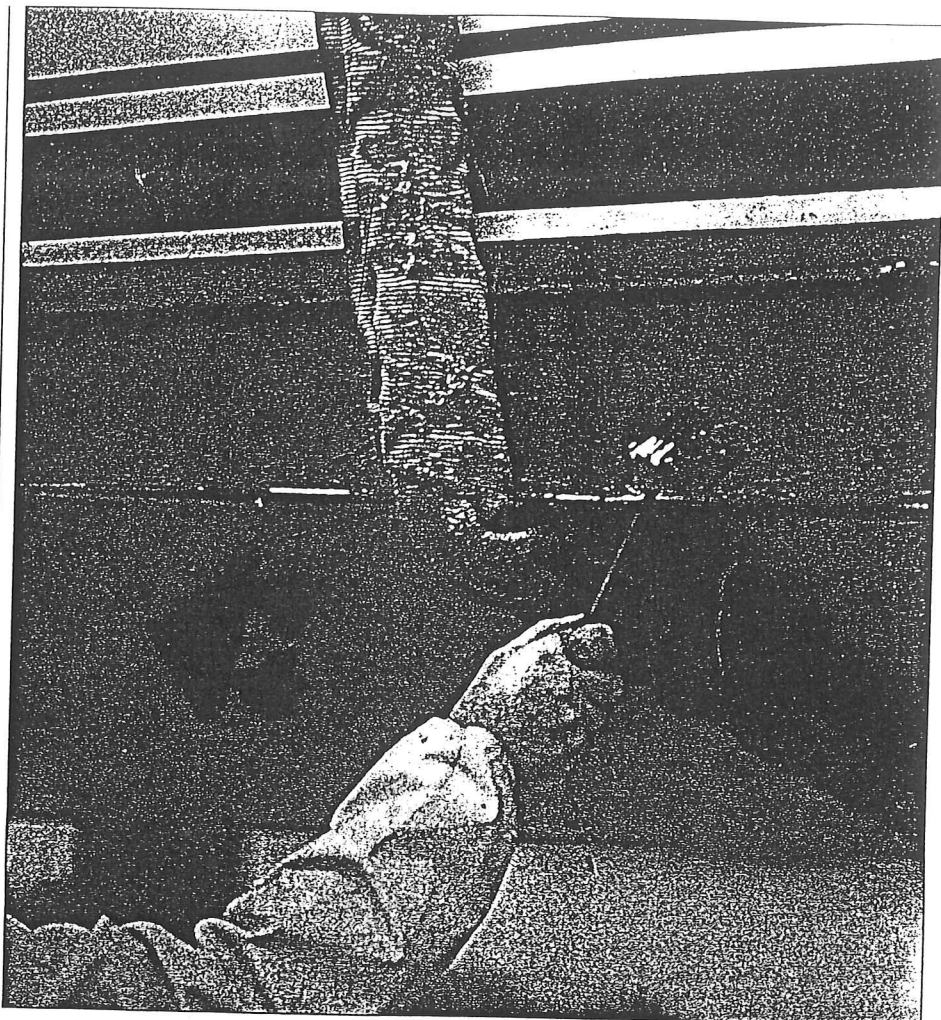
Hull – bottom: *Suffers from antifouling detachment. There are many antifouling blisters apparent, but these are thought to be caused by incompatible antifouling coats being applied. Unfortunately due to inclement weather it was not possible to check general moisture levels over whole of the bottom, but one area was cleaned, dried and tested at 16% which is an acceptable level considering the weather conditions on the day. On the port side there is a nasty abrasion to one of the spray rails. Recommendation: the bottom should be scraped clean of antifouling, the area on the spray rail where it is damaged should be built up with matching gelcoat, faired and polished to original finish. The bottom should be antifoul primed, then coated with a coat of new antifouling.*

Top: removing the antifouling prior to examination for osmosis. Above: one of the cracked frames on the starboard side.

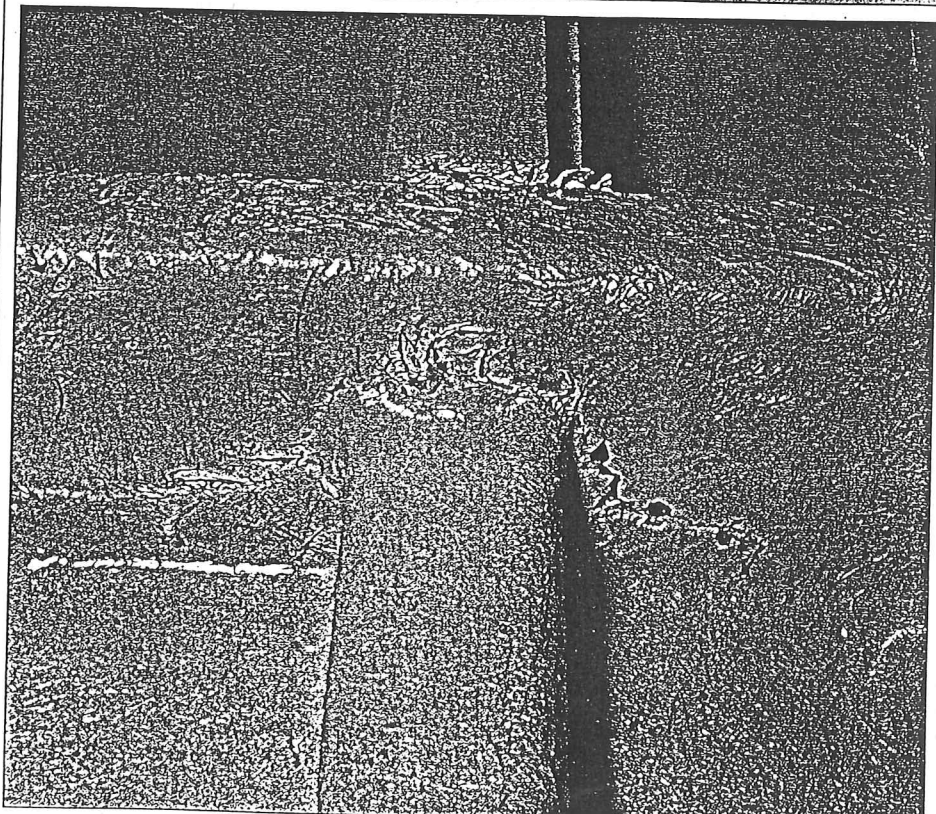
Hull internal: *Inspected wherever access was possible. In the fore-bulk the standard of GRP finish was rough and there was still a considerable amount of building swarf evident in the bilges. Under the saloon sole in the tank space there were three cracked frames on the*

starboard side and two on the port side. This appears to have happened when the vessel had either been craned out and put down hard, or it had been subject to some severe weather conditions in the open sea. It is therefore recommended that the top hat sections should be cut back, acetoned clean and new layers of GRP should be bonded to the top hat sections and the fore and aft stringers with a maximum of 8oz chopped strand mat.
