PRINCESS 30DS

**SUBJECT
TO SURVEY**

Marine Projects' 30ft cruiser is a firm favourite with both offshore and inland boaters - and deservedly so. Tony Jones joins surveyor Frank Verrill for a close look at a 1985 model

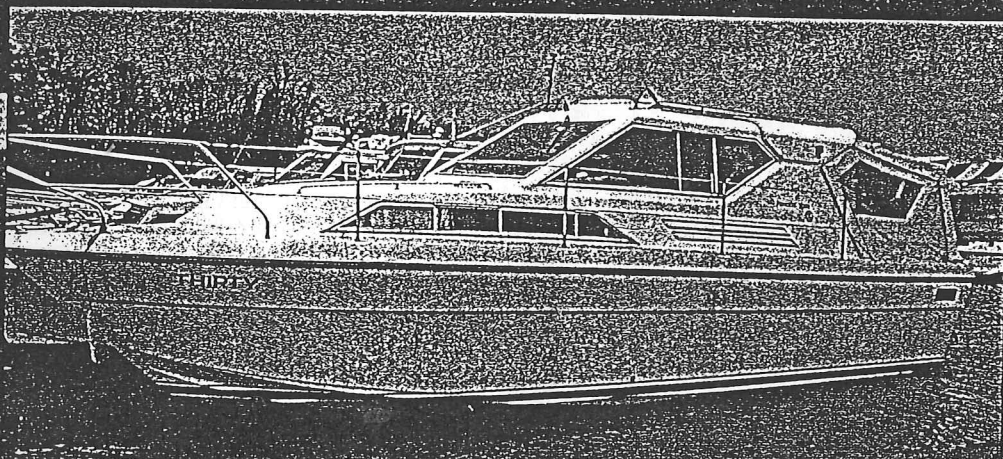
Hull internal: *Inspected wherever access was possible. In the fore-bulk the standard of GRP finish was rough and there was still a considerable amount of building swarf evident in the bilges. Under the saloon sole in the tank space there were three cracked frames on the*

starboard side and two on the port side. This appears to have happened when the vessel had either been craned out and put down hard, or it had been subject to some severe weather conditions in the open sea. It is therefore recommended that the top hat sections should be cut back, acetoned clean and new layers of GRP should be bonded to the top hat sections and the fore and aft stringers with a maximum of 8oz chopped strand mat.
